Copper vs Stainless Steel Tubes

Corrosion issues

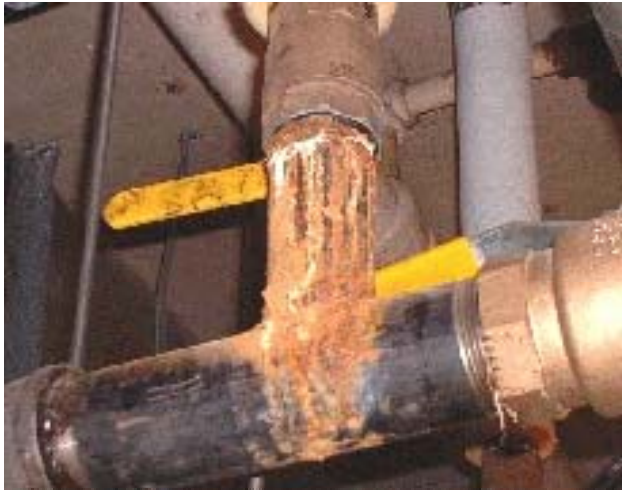
Galvanic Corrosion – Brass vs MS

Galvanic Corrosion - Another example of the higher corrosion activity usually existing at direct brass to black iron connections.

At low corrosion rates, galvanic corrosion may be negligible, but usually increases greatly once corrosion rates exceed 5 MPY.

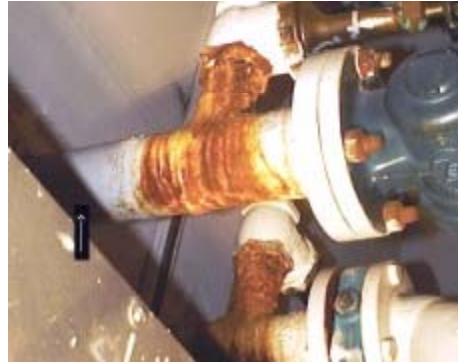
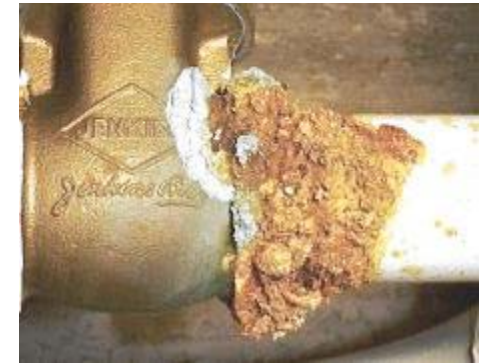
- **Galvanic Corrosion** - An extremely common problem area due to the failure to install galvanic insulators between carbon steel pipe and either brass valves or copper pipe.

Combined with schedule 40 pipe and a moderate corrosion rate, galvanic corrosion will often produce premature failures with 6-10 years.

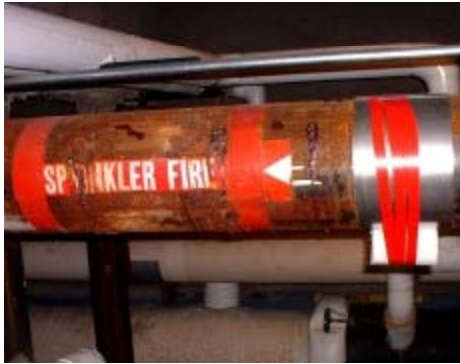
- **Pitting Corrosion** - The presence of one repair clamp and five nearby pinhole leaks confirms that a severe corrosion problem exists at this fire sprinkler piping location.

This is made worse by the original installation of thin wall schedule 10 stock, where little wall thickness loss can be tolerated before reaching minimum acceptable limits.

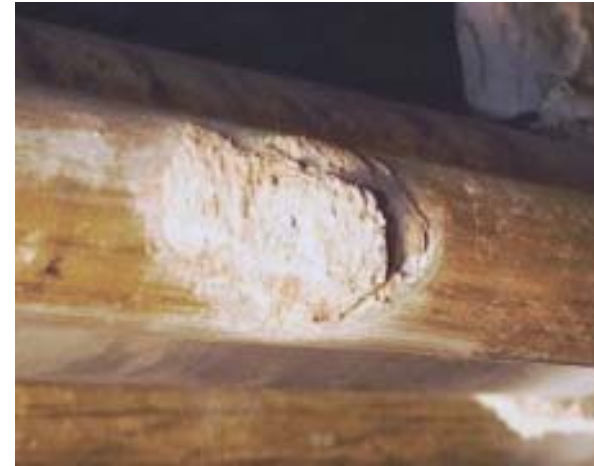
- **Dezincification** - Typical surface deposit resulting from the dezincification of brass pipe due to old age and/or an aggressive water condition.

Over many years, the zinc component of the metal is leached out to leave copper. Deep pitting is initiated and the pipe becomes porous prior to producing an actual leak, and leaving a corrosion product behind.

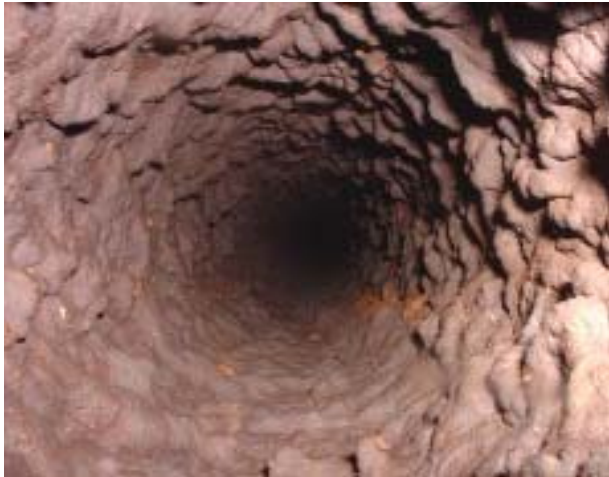
- **Heavy Deposits** - A common corrosion result following decades of fire standpipe service.

This galvanized steel pipe is barely recognizable as such, and accumulated an overall restriction of approximately 1 in. across this 6 in. diameter ID. Concern was raised once pinhole failures started at the threaded joints, with UT testing showing only 0.050 in. remaining in that area.

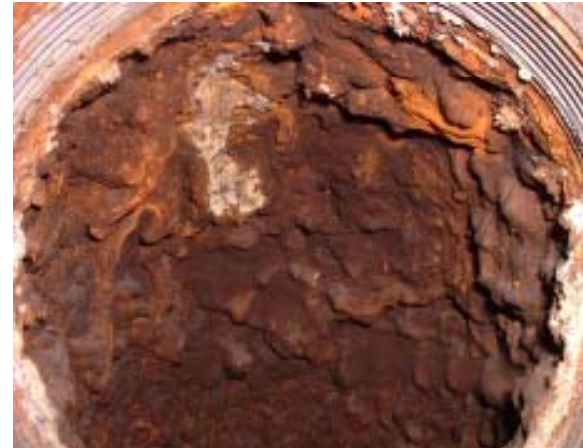
- **Galvanized Pipe**- Over 62 years of carrying New York City domestic cold water in this 8 in. galvanized wrought iron line produced this eventual result.

UT testing showed deep under deposit pitting well throughout the pipe, and an overall corrosion rate of near 3.5 MPY. Corrosion produced both constricted smaller diameter pipe, and pinhole failures.

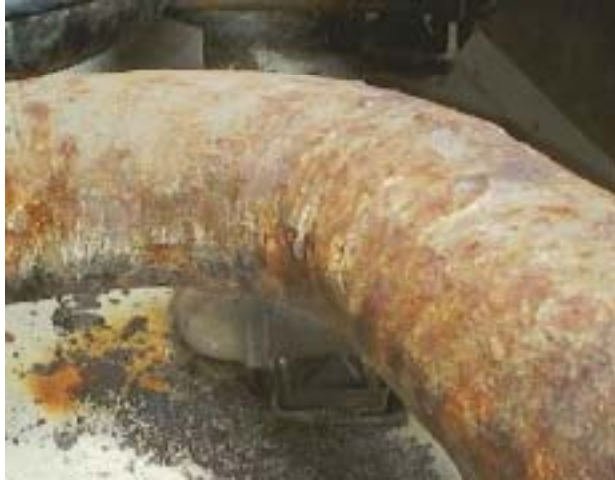
CUI Corrosion - Roof level pipe often suffers even higher exterior metal loss due to the combined effects of moisture condensation, direct water infiltration, and insulation damage.

Such heavy deterioration is usually only discovered after a leak occurs.

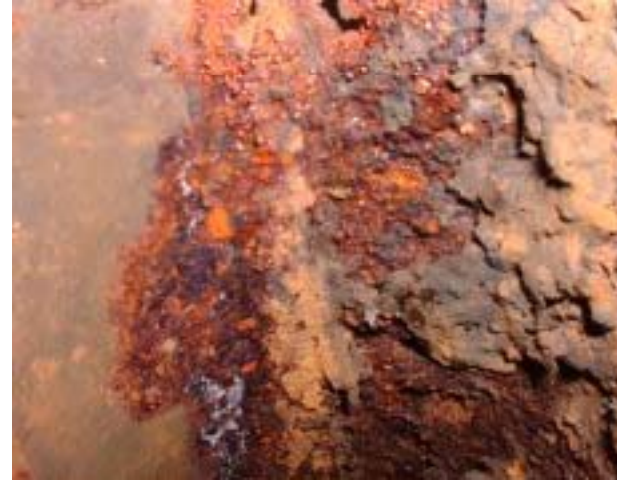
Localized Pitting - Partially water filled systems produce widely varying wall loss typically along the bottom.

For this dry fire sprinkler system, testing showed virtually new pipe after 25 years at the top, shown at the left. The wet pipe bottom however, shown at the right, was totally deteriorated to the point of failure.
