# **Corrosion of Low-Carbon Steel Under Environmental Conditions at Hanford: Two-Year Soil Corrosion Test Results**

**R. P. Anantatmula**  
Westinghouse Hanford Company

Date Published  
November 1995

**Document Number:** WHC-EP-0891

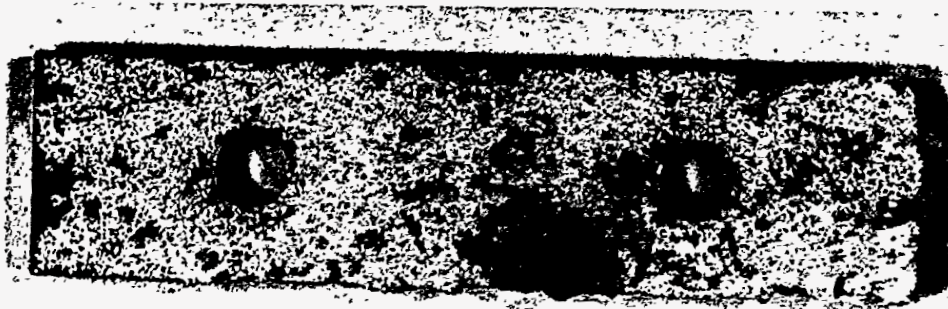
**Bare Carbon Steel  
9-20-95, 10 ft Depth  
Front Surface (Exposed to soil)**

**Bare Carbon Steel  
9-20-95, 10 ft Depth  
Back Surface (In contact with specimen holder)**

Figure 3. Photographs of Bare Carbon Steel Specimen  
After 2 yr. Exposure to Hanford Soil at 10 ft. depth

The bare low-carbon steel displayed a rough surface typical of underground corrosion after 2-yr of exposure (see Figure 3). The specimen located at 3-m had one spot on an edge that might be indicative of pitting but the location on the

edge of the specimen prevented any determination of depth. From the appearance of the uncleaned specimens, this was the only carbon steel specimen that may have actually pitted.
